STRUCTURAL
INTEGRITY RESERVE
STUDY ANALYSIS

DELHAVEN CONDOMINIUMS

1700 S Ocean Blvd

FLORIDA TECHNICAL, INC.

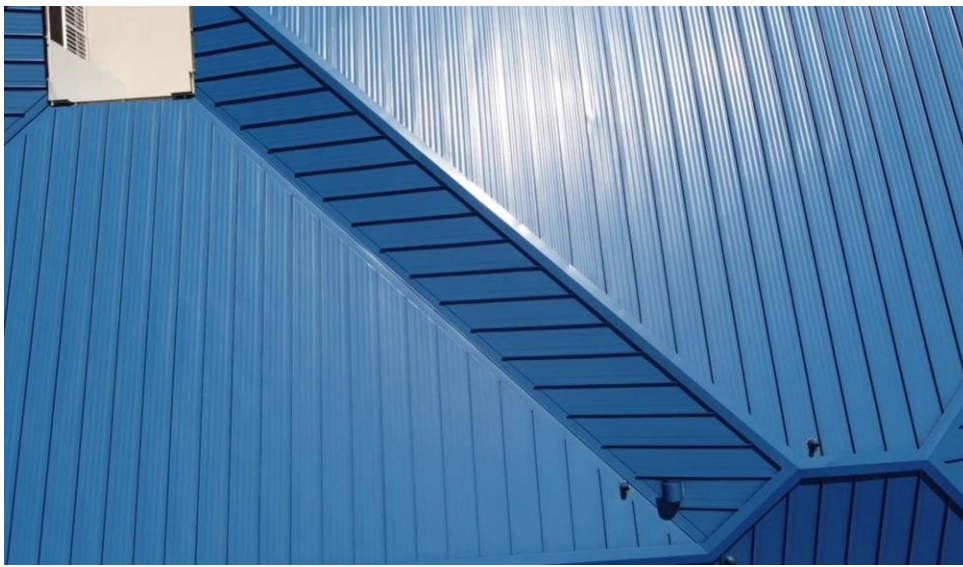
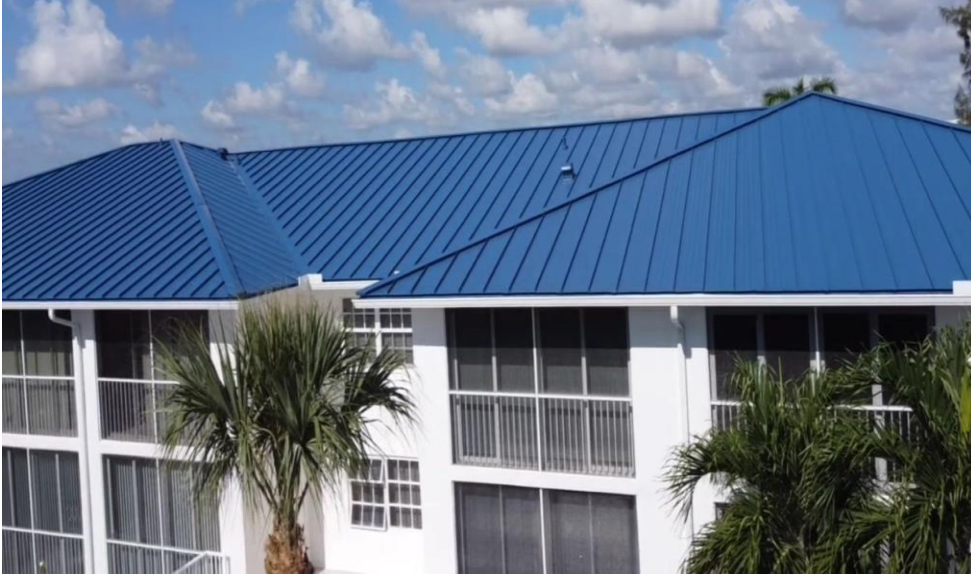
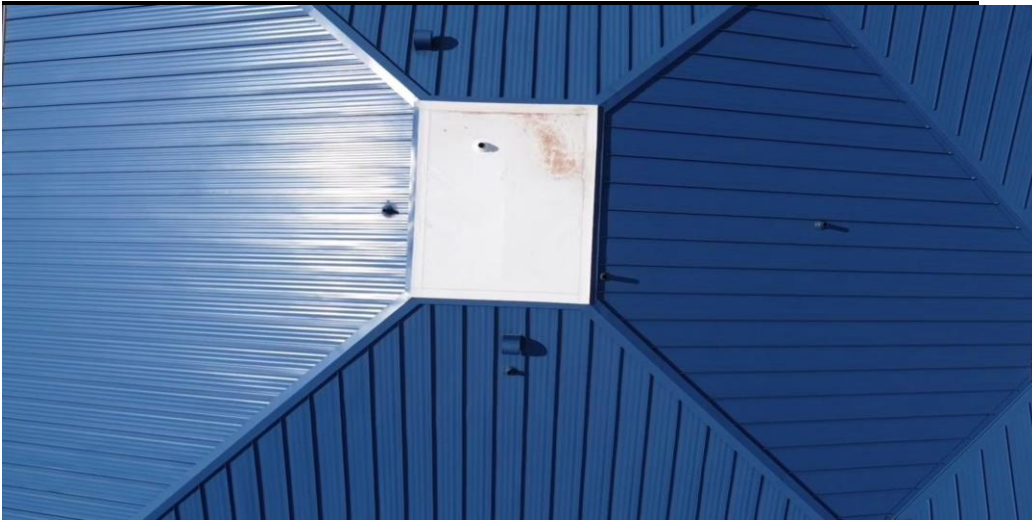
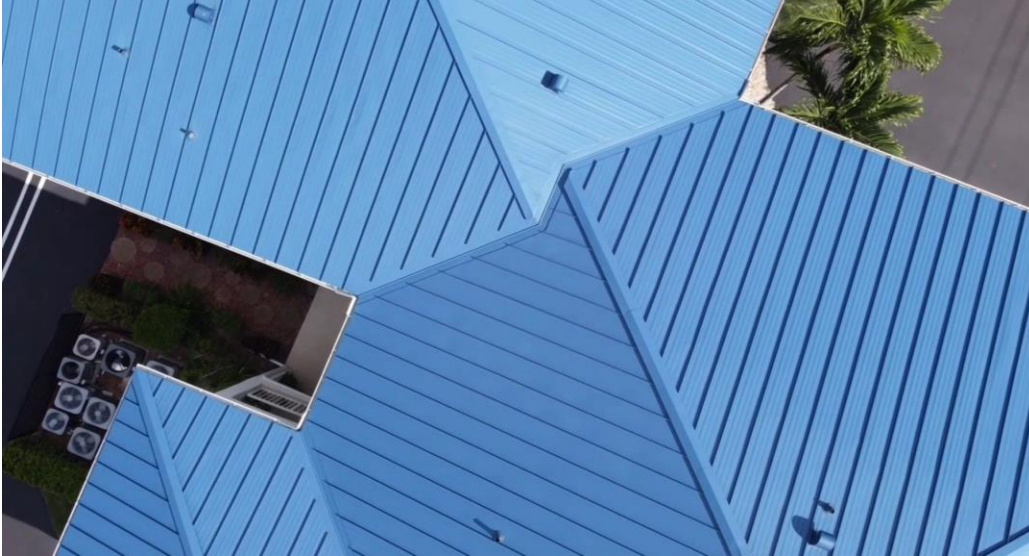
ROOF:

Roof assessment was done via drone. Per our assessment of the area, we did not find any damage.

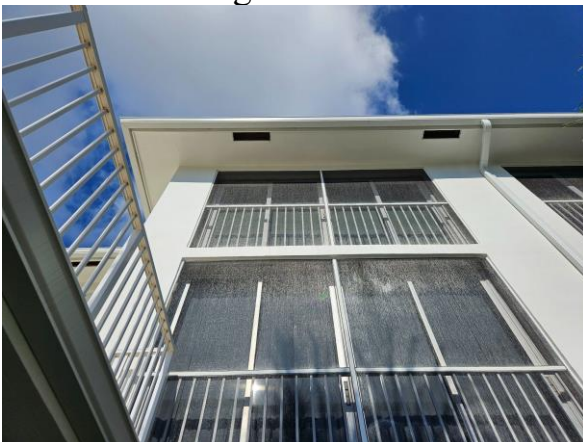
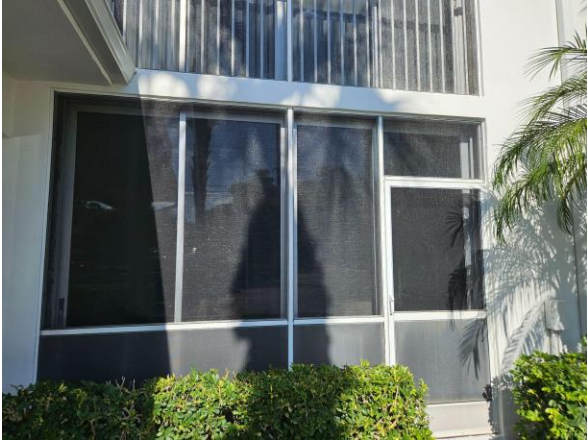
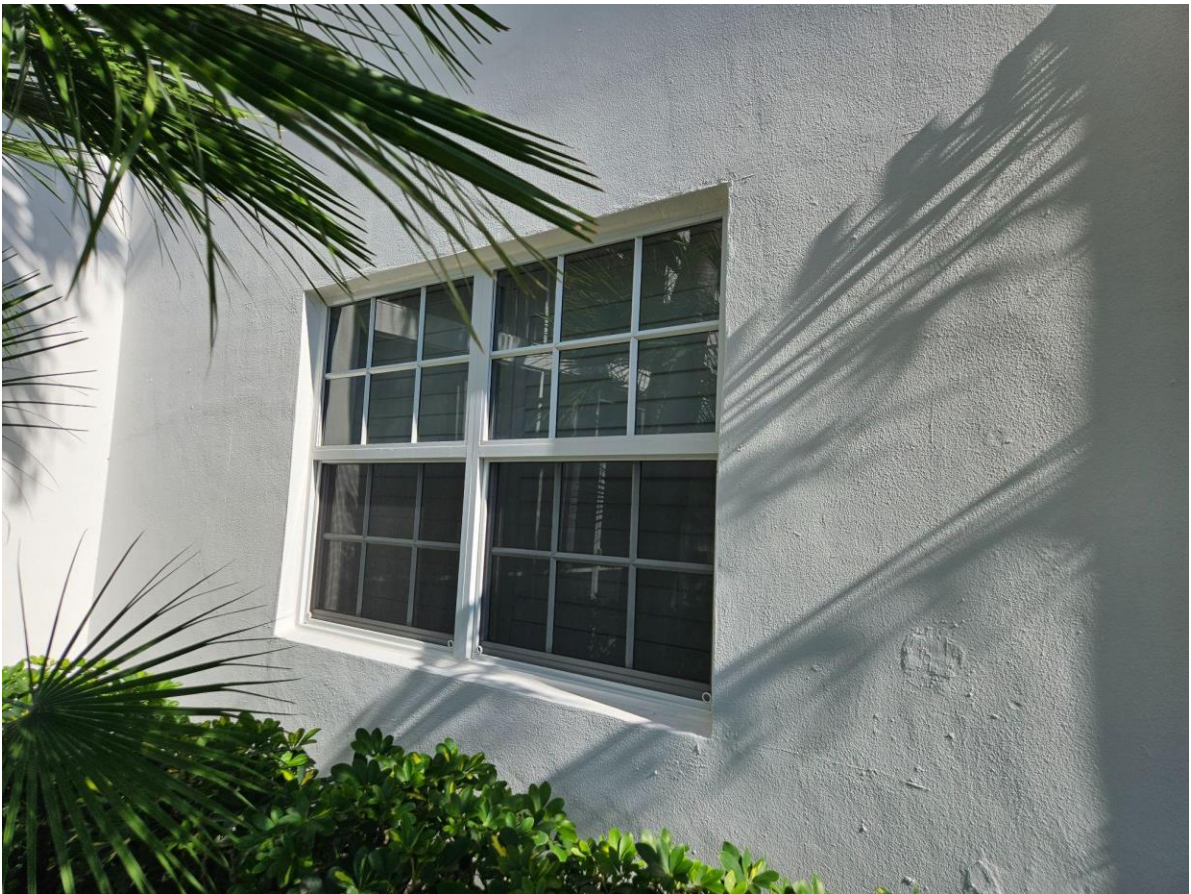
Exterior:

Per our assessment of the property, we did not find any structural damage to the area.

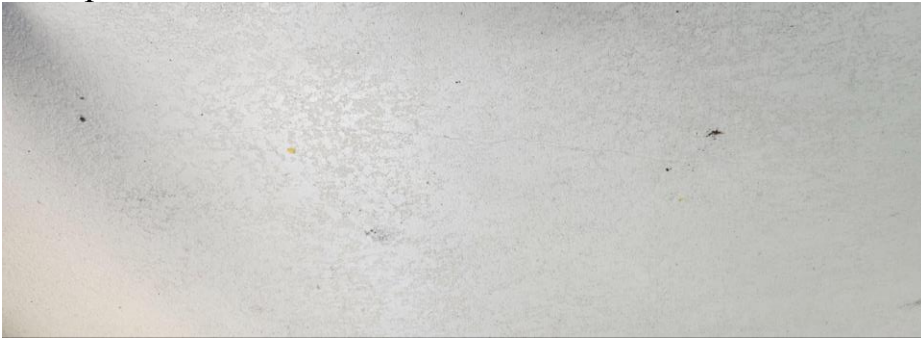
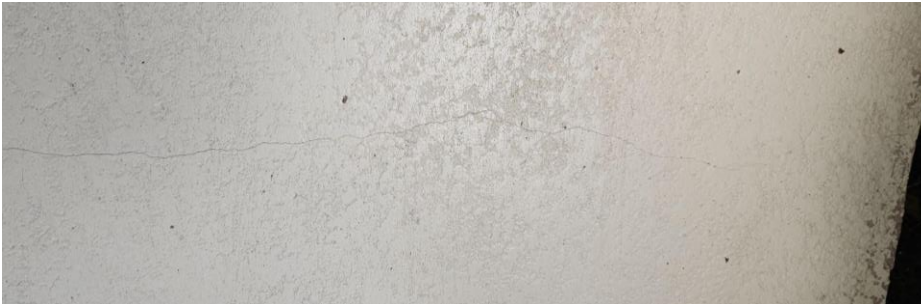
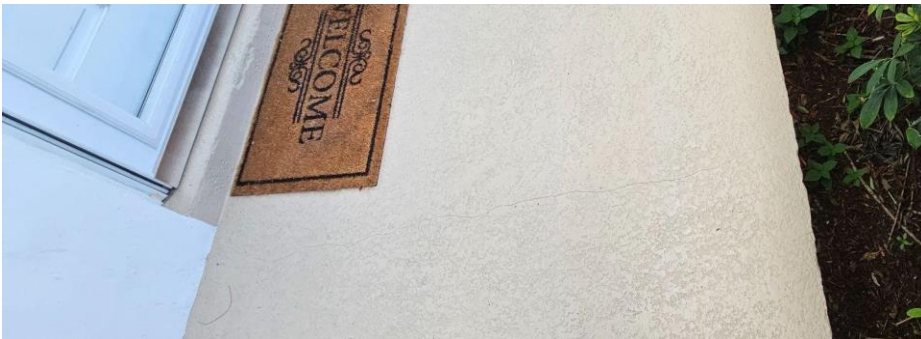
“A” crack in front of unit 6 and corner of unit 6.

Multiple “A” cracks in front of unit 7.

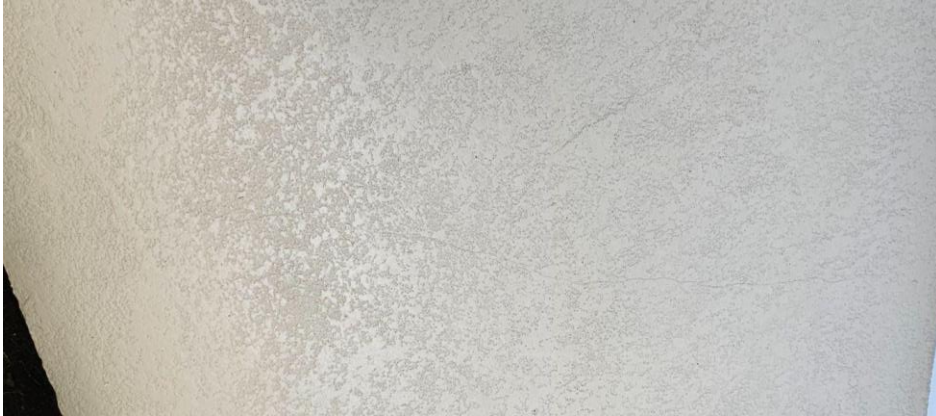
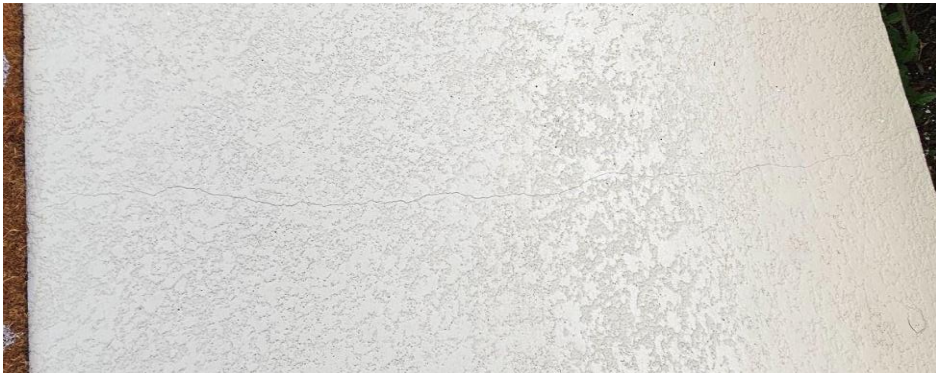
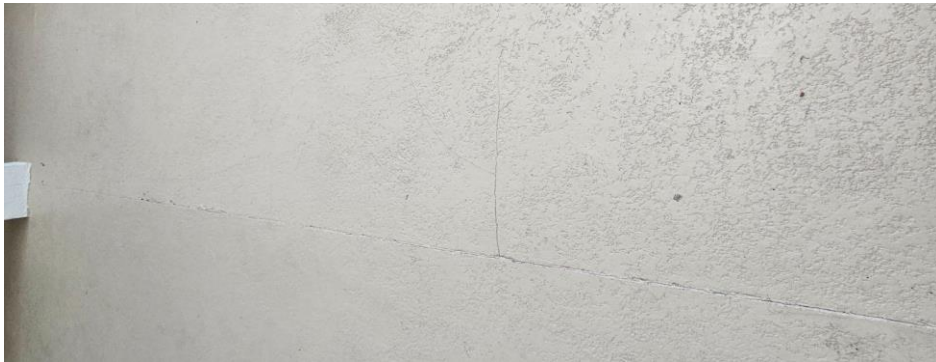
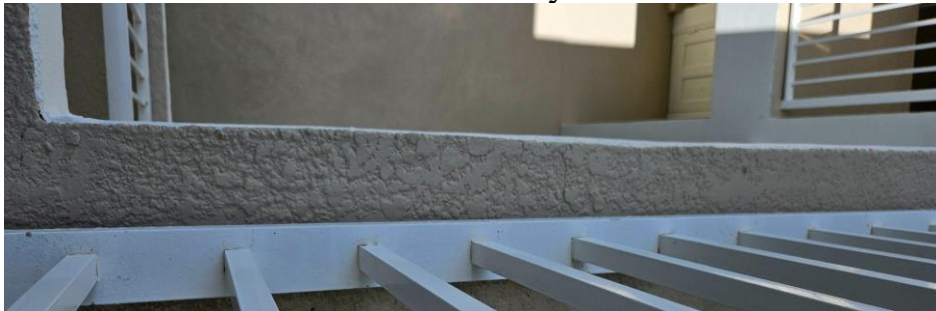
2ND FLOOR

A crack under railing in front of unit 18 in front of window.

A crack in front of unit 10 all the way to rail.
